# NHTI, Concord's Community College Campus Erosion Mitigation Plan

Joy Roberts and Tracey E. Lesser

Department of Natural Sciences

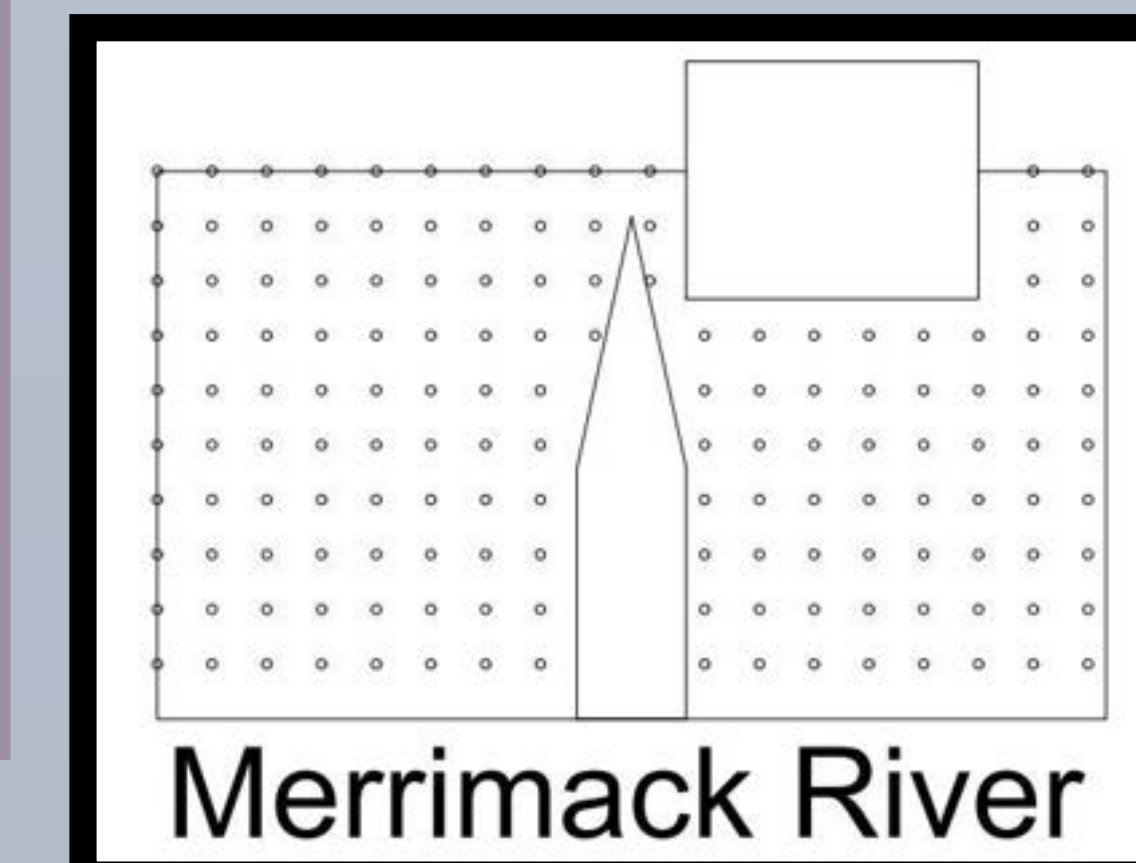
Figure 7. Diagram displaying planting spacing around erosion (where staircase will be placed) and old pump house foundation

**Key: O = 3' spaced planting spot**

- Native plantings put right into riverbank (Figure 7.)
- Utilizing seeds, live stakes, and cultivated growths
- Plants chosen are low maintenance and hardy

Plants will be planted at an average rate of 3 feet apart. The low-cost estimation considers the idea of volunteered plantings while the high cost considers paid plantings (Figure 8.).

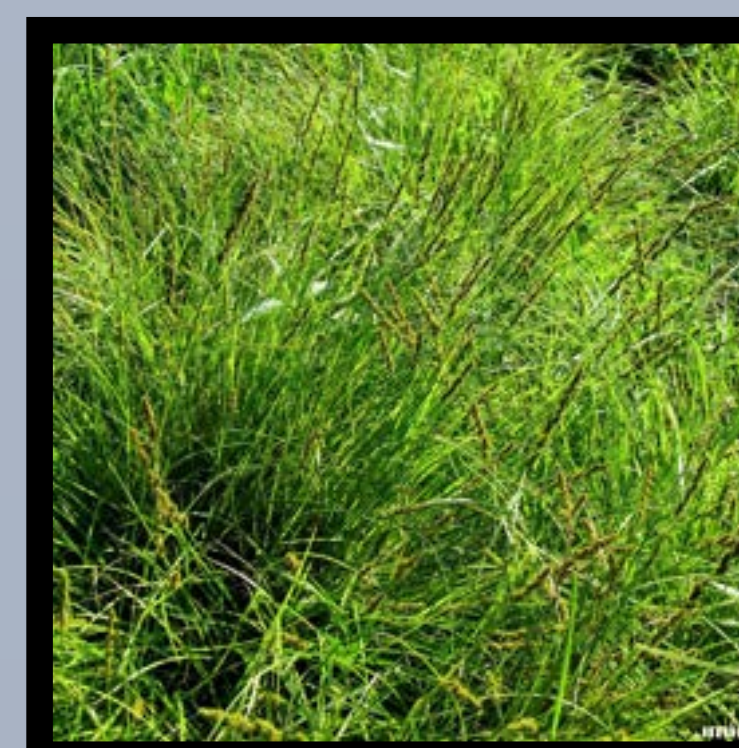
Figure 5. Fox Sedge

The following vegetation are all native plants which will stabilize the riverbank with strong root systems and run-off absorption (Figures 2-5) :

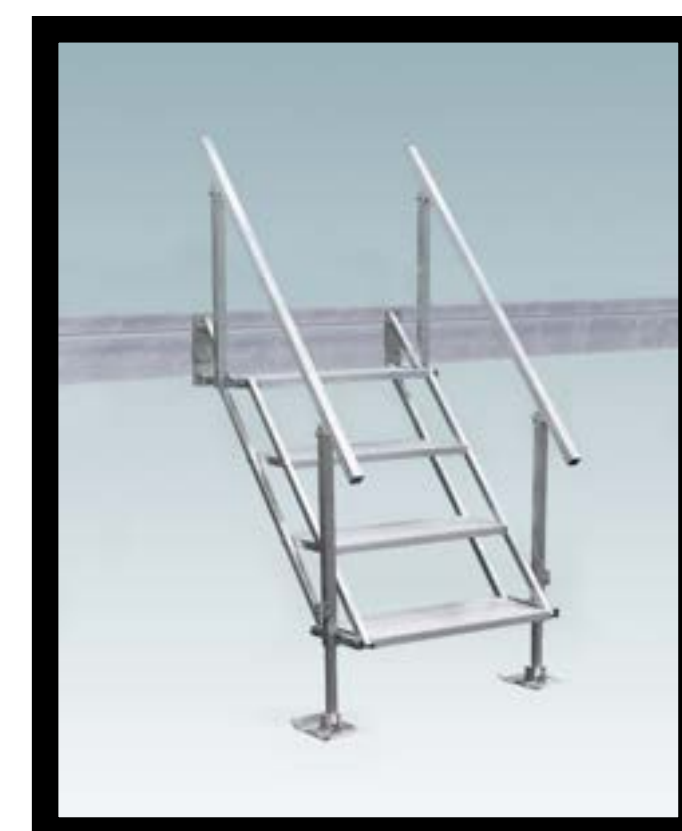
Figure 6. Premade stairway

An effective way to create a safe and non-eroding water access is to implement a pre-made metal staircase (Figure 6.). The staircase will be held in place by metal stakes put into the riverbank. These stairs will be removable for winter and will allow vegetation to grow underneath.

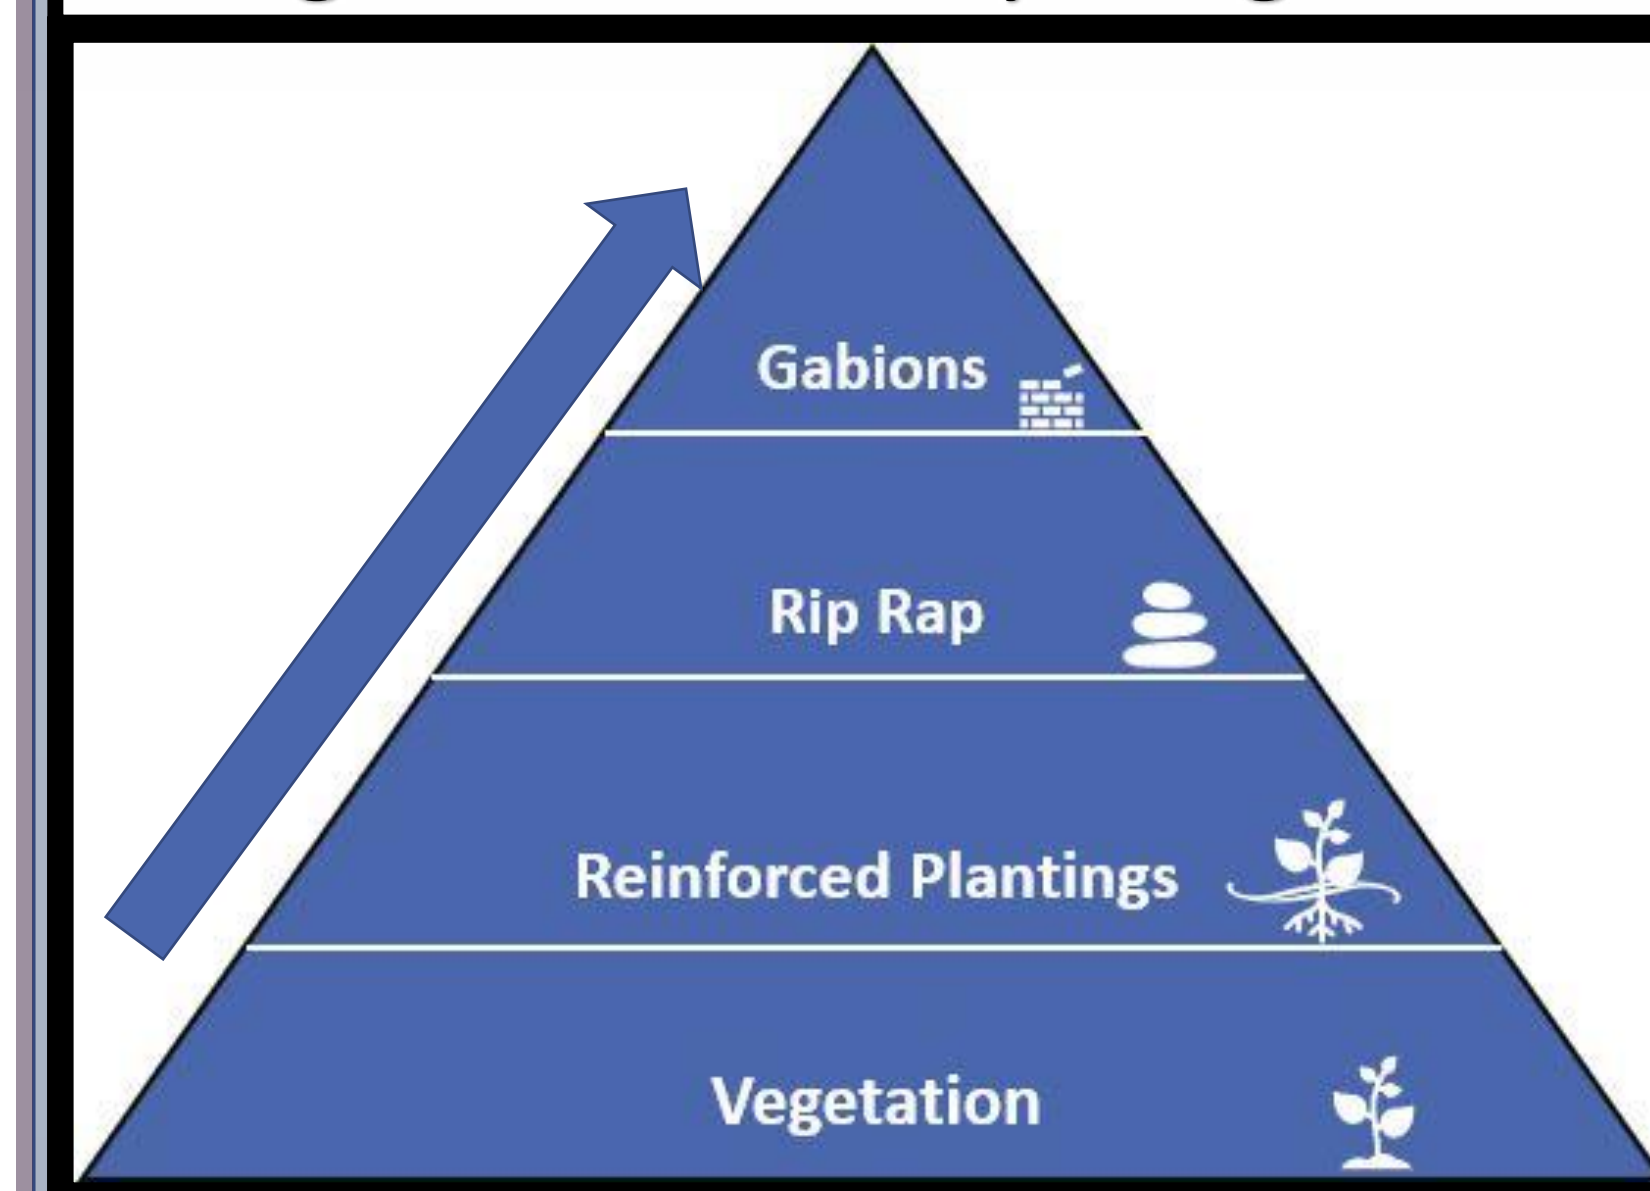
Figure 9. Shows progression of mitigation intensity as previous efforts alone fail

Should the vegetation not prevent further erosion there is a hierarchy of erosion mitigation (Figure 9.). As the lower levels fail there is a progression of intensity. For this design fail the progression would be as follows:

- Reinforce plantings with coir mats/logs
- Have surveyed for consideration of riprap or gabions
