Background

Beaver Lake is a 137-acre lake located in Derry, NH. The watershed has changed over the last 50 years due to population and business development [1]. New Hampshire Department of Environmental Services (NHDES) and the Volunteer Lake Assessment Program (VLAP) have partnered with the community over recent years, actively engaging in selecting management strategies that can be implemented to solve problems within their communities (Derry, Auburn, and Chester)[5].

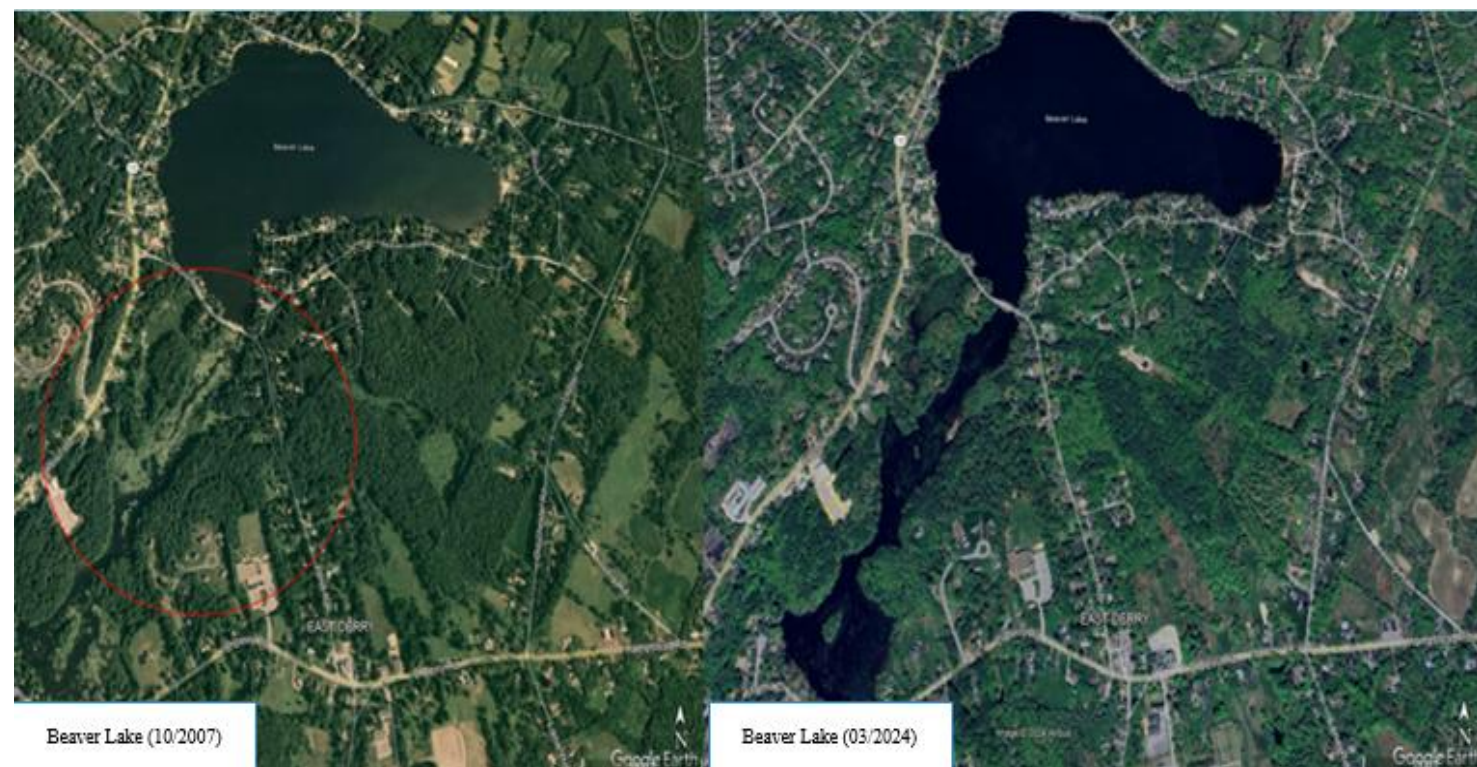
Figure 2 shows an aerial photo of Beaver Lake taken in October 2007 and March 2024.

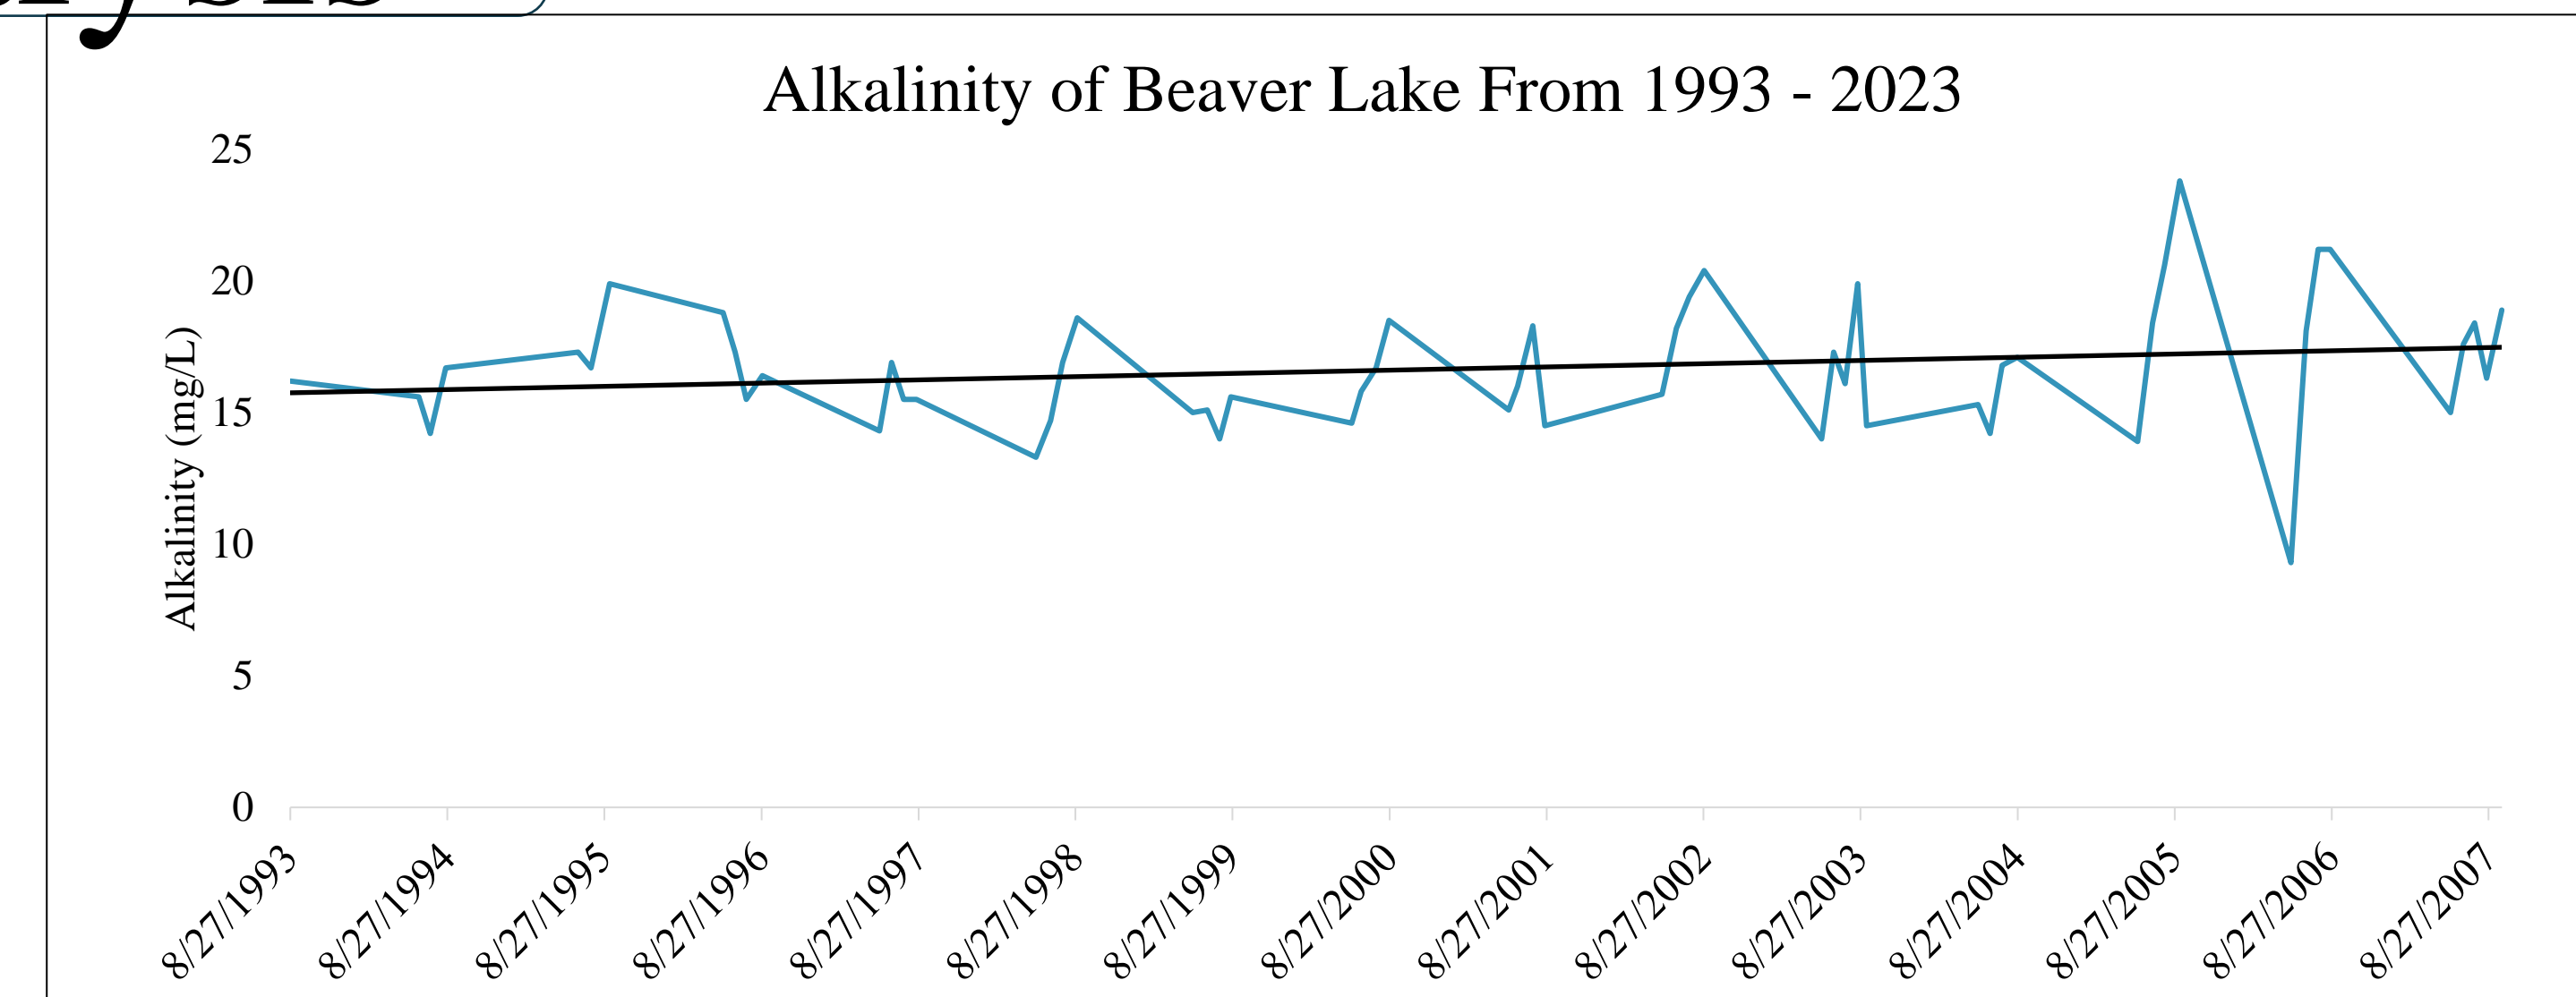
Figure 10. Total Alkalinity for Beaver Lake from 05/1990 to 05/2022

Alkalinity has increased from 16.6 to 18.2 (mg/L).

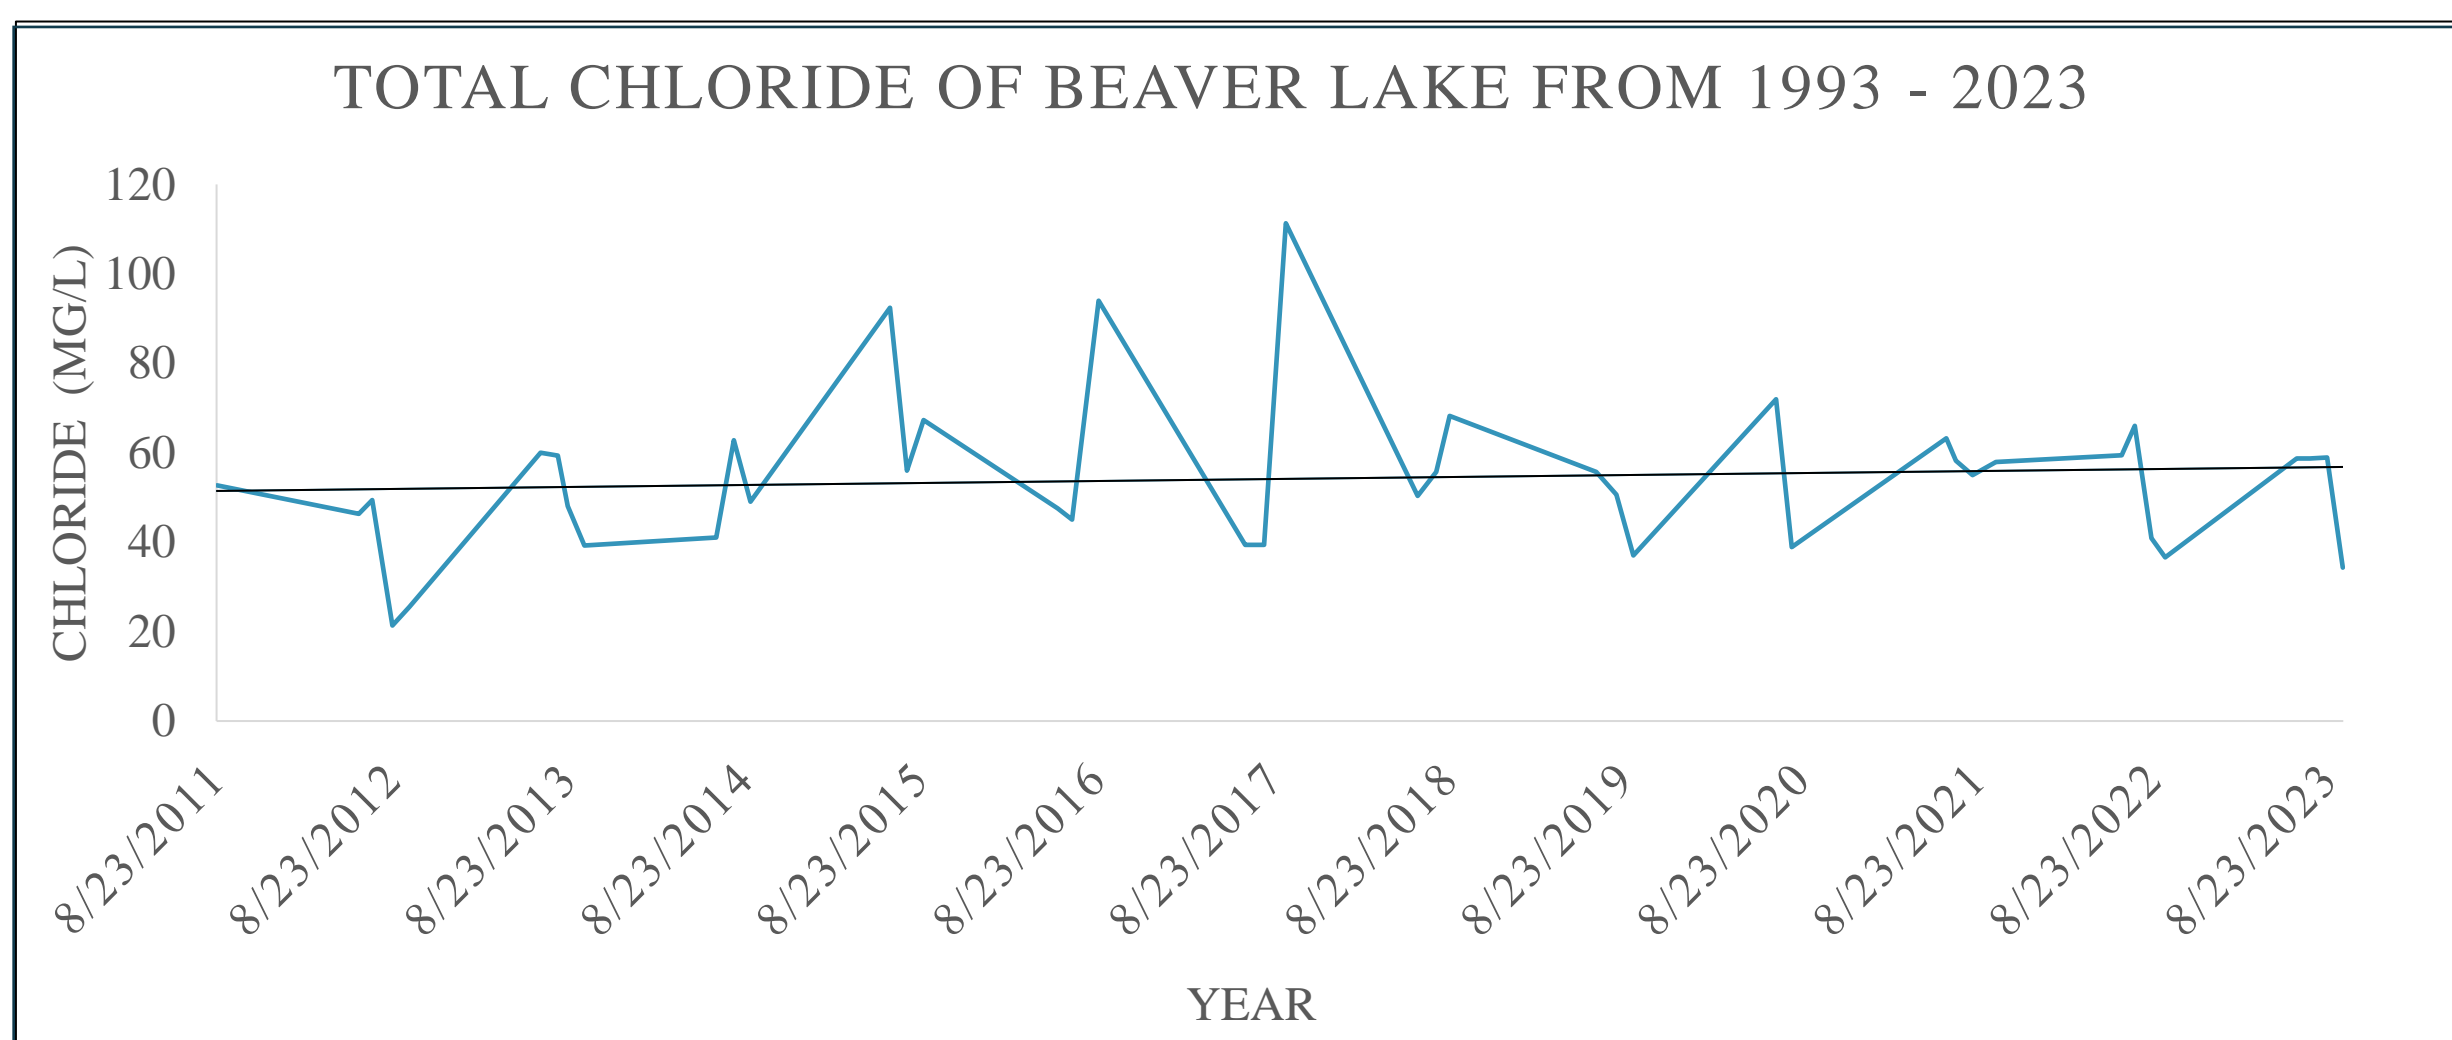
Figure 11. Total Chloride Concentrations for Beaver Lake from 08/2011 to 08/2023

Chloride levels have increased in Beaver Lake from 52.7 to 58.8 (Mg/L)

Additionally, although chloride levels in Beaver Lake have shown an upward trend, they remain within the recommended range of 230 mg/L, as outlined by NHDES [4]. This trend is depicted in Figure 11, indicating a consistent monitoring effort over the past two decades.

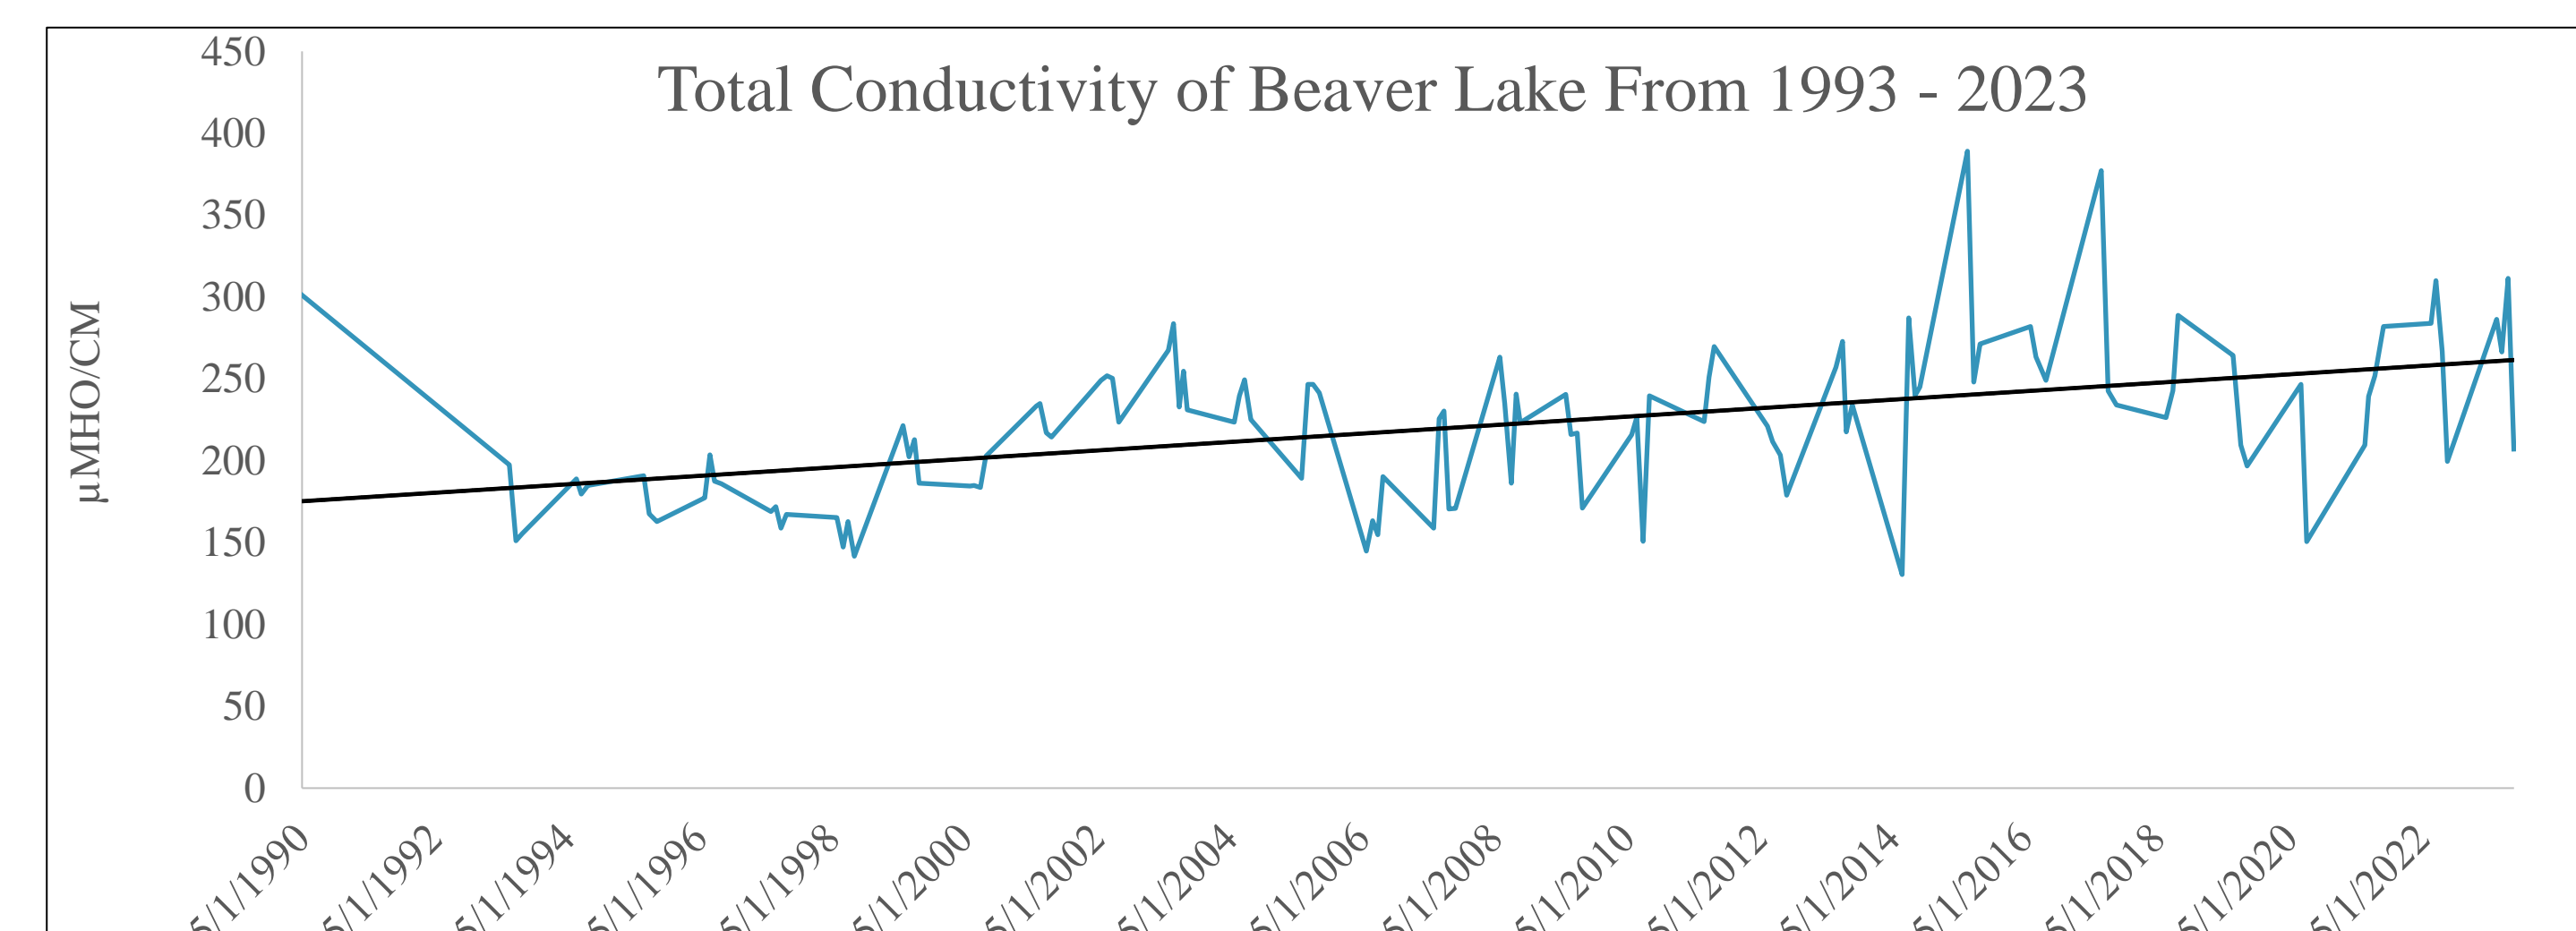
Figure 12. Total Alkalinity for Beaver Lake from 05/1990 to 05/2022

Conductivity has increased from 175 to 225 (µS/cm)

Furthermore, the data collected by NHDES and VLAP indicate that chloride and conductivity levels across the state have consistently stayed within the recommended limits over the same period. This suggests effective management practices and ongoing monitoring efforts to protect and preserve water quality in Beaver Lake and beyond. Continued vigilance and collaboration among stakeholders will be essential in maintaining and further improving the health of our water bodies.
