## Angle Pond

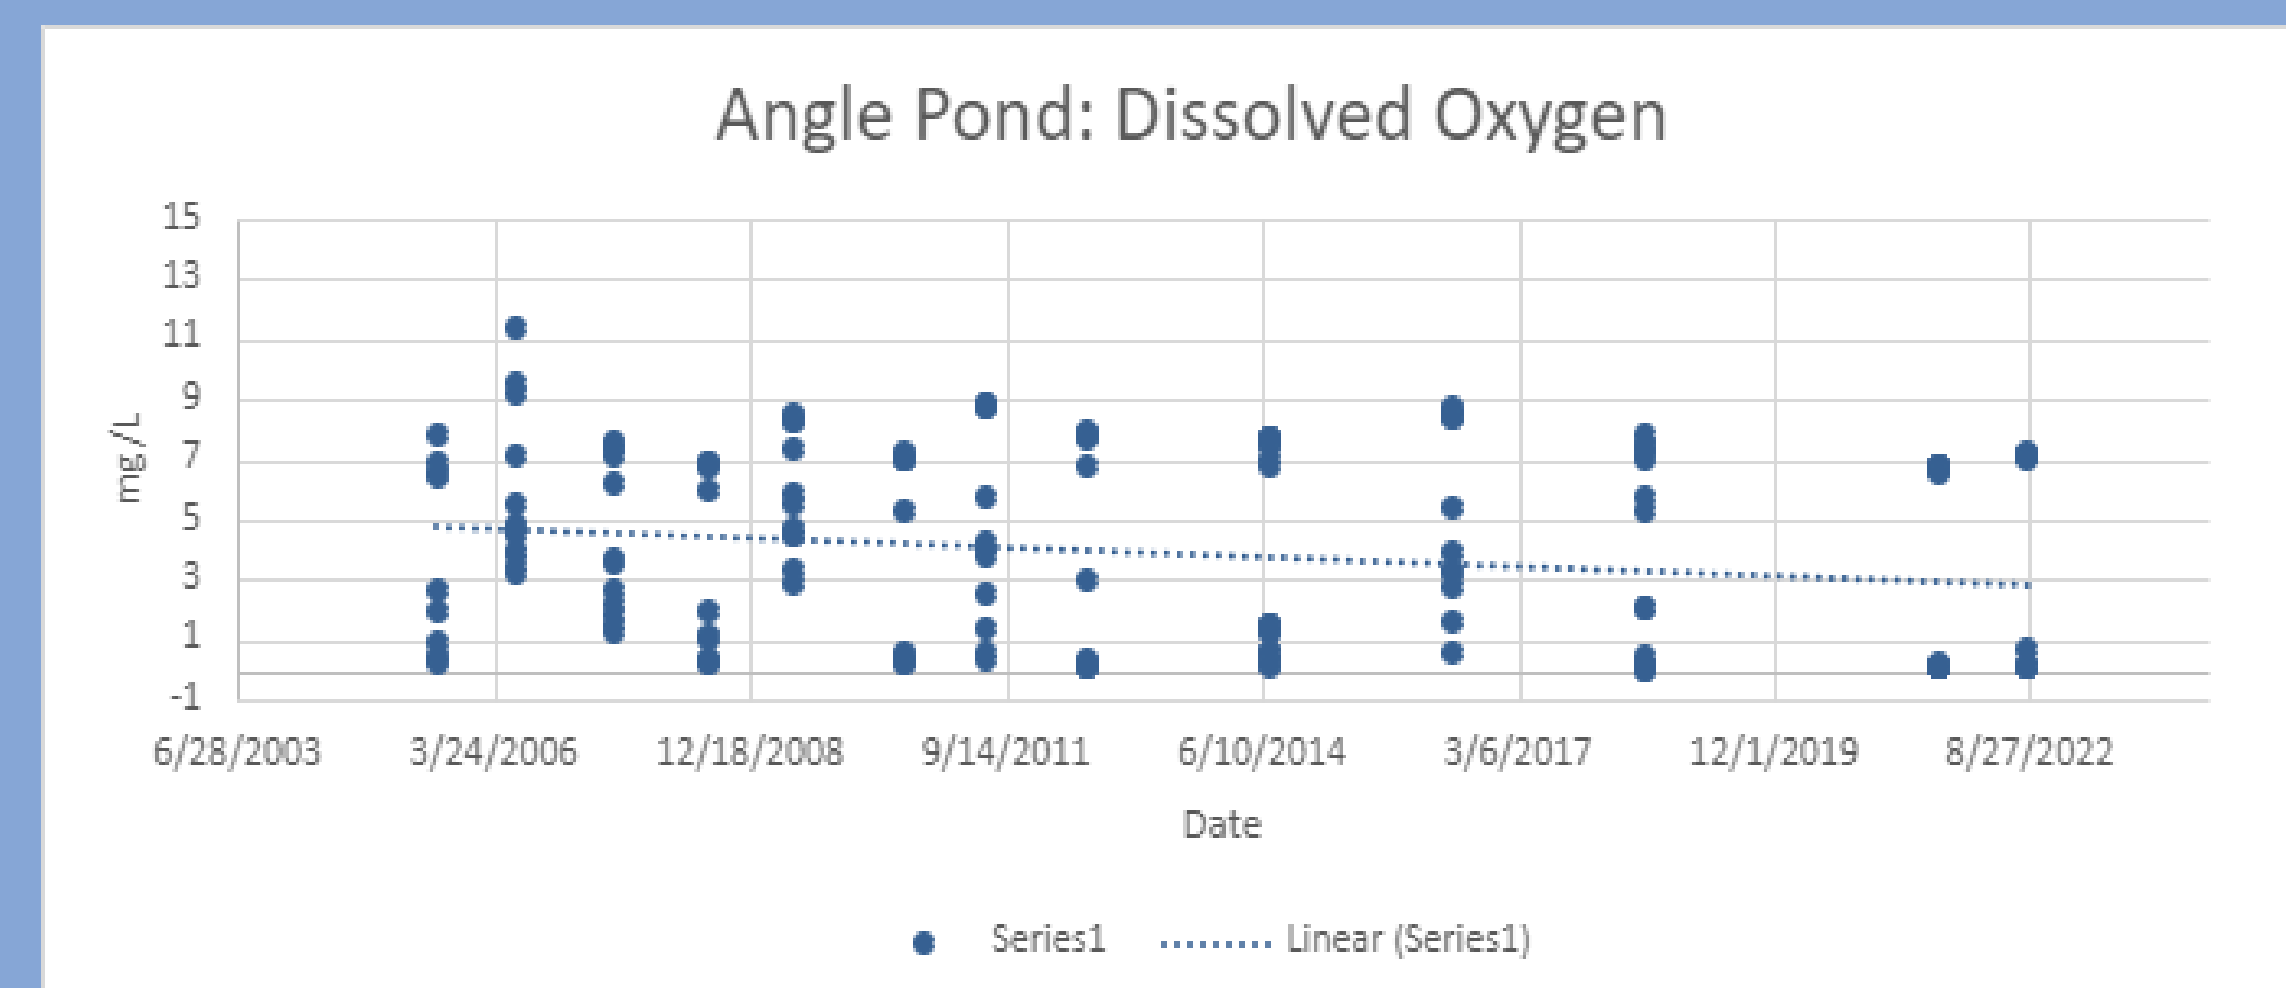
Figure 6. A graph displaying the concentration of dissolved oxygen in Angle Pond over time.

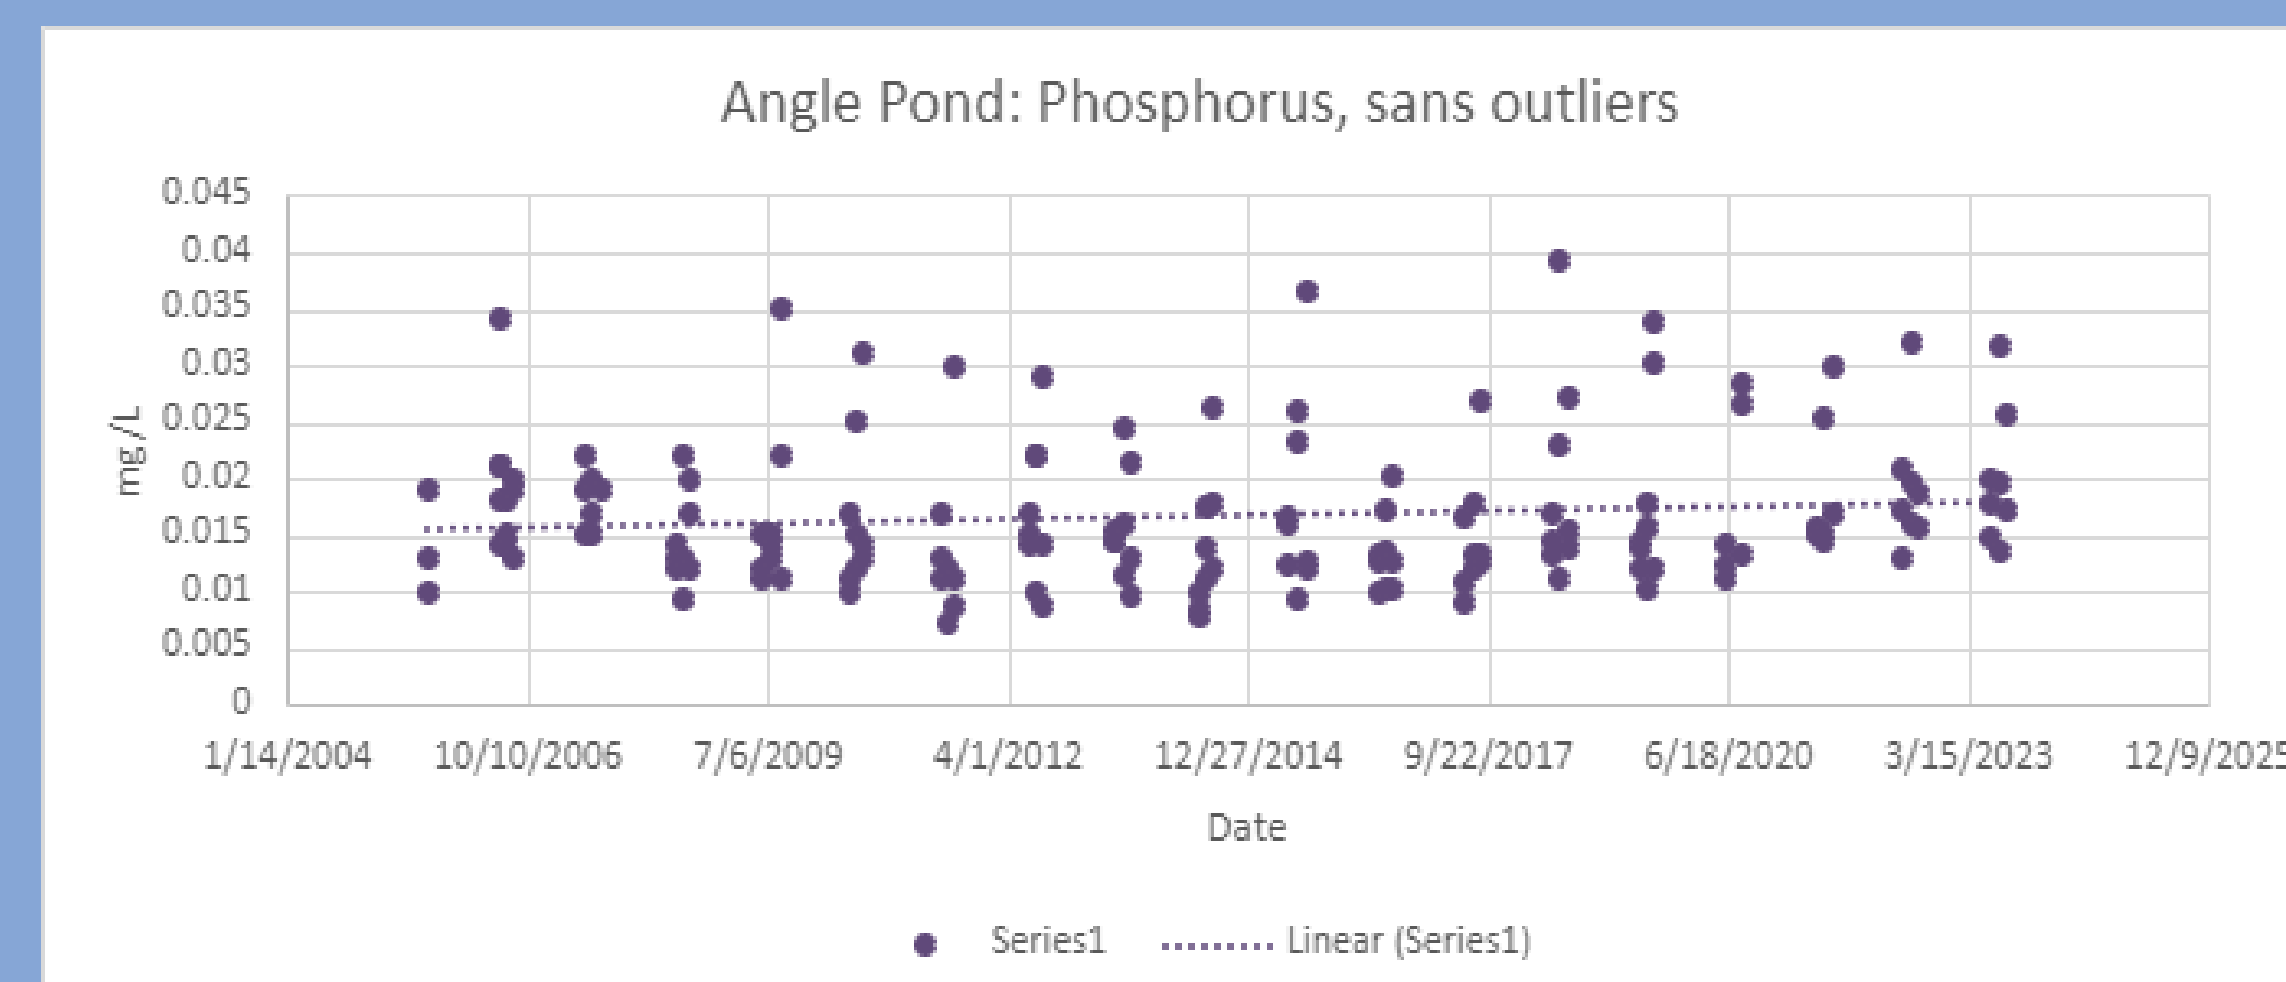
Figure 7. A graph displaying the concentration of phosphorus in Angle Pond over time.
